NUMBER: 23-008-07

Oil Canning, Popping, or Thumping-Like Sound From Front Passenger Area During Body Twist

2007 (JK) Wrangler

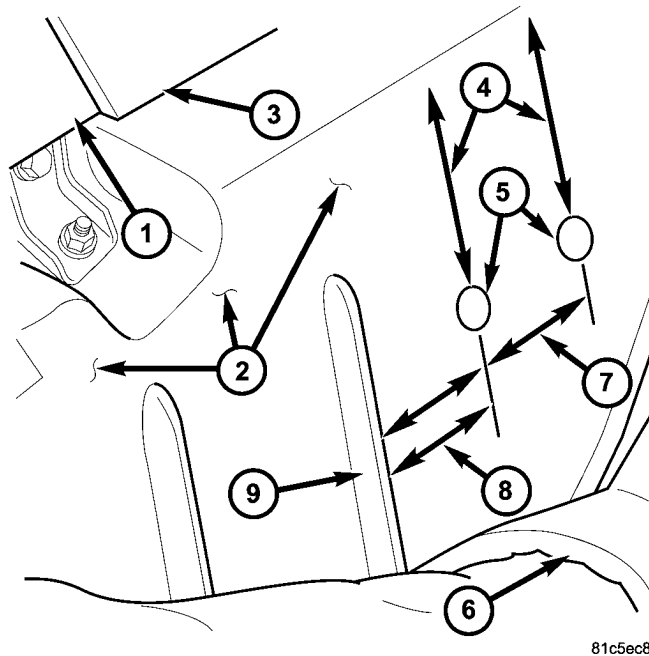
Fig. 1 FLOOR PANEL - RIGHT FRONT TUNNEL

The customer may experience an oil canning, thumping, or popping-like sound from the front passenger area. The sound may be misdiagnosed as a suspect shock absorber or rebound bumper.

1. Pull the right front (passenger side) carpet away from the transmission tunnel area.
2. From the figure locate the suspect area on the floor panel (**Fig. 1**), in the area of the transmission tunnel where the panel may flex.
3. When condition is present, applying hand pressure to this area will often cause the panel to flex and recreate the oil canning-like sound.

4. Per the figure, use a rubber mallet to create two (2) depressions in the floor panel. Each depression should be approximately 51 mm (2 inches) in diameter and 3 - 4 mm (1/8 inches) in depth.
5. Verify that the "oil canning" condition has been corrected.
6. Install the right front carpet.

- 1 - Right front corner of center console
- 2 - Right side transmission tunnel area of front floor panel
- 3 - Bottom corner of instrument panel center stack
- 4 - Measure down 71 mm (3 inches) from transition (curve) in floor panel.
- 5 - Each depression to be 51 mm (2 inches) in diameter and 3 - 4 mm (1/8 or 0.125 inches) in depth
- 6 - Right front floor carpet and pad
- 7 - 51 mm (2 inches) distance between each depression. Measured from center-to-center of each depression
- 8 - 51 mm (2 inches) distance from reinforcement rib in floor panel to center of closest depression
- 9 - Reinforcement rib in floor panel
