**NUMBER:** 23-019-07

Wind-Like Sound At A-Pillar Of Windshield Frame

2007 (JK) Wrangler

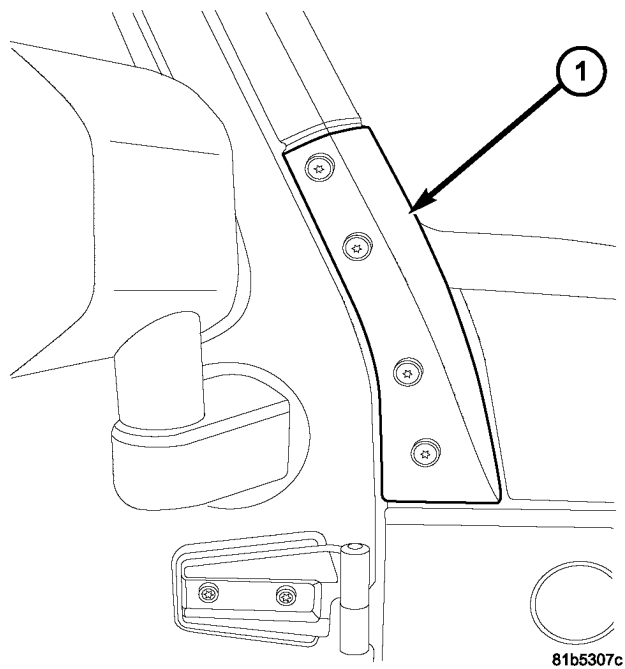
**Fig. 1 WINDSHIELD FRAME REINFORCEMENT BRACKET**

***\*\* The customer may experience a wind-like sound along the left and/or the right A-pillar, at speeds above 30 kph (20 mph). Sound is a rush or "open cavity" like sound. The sound appears to be coming from the middle to top half of the windshield frame A-pillar. \*\****

1. Remove windshield frame reinforcement bracket on A-pillar with wind-like sound (Fig. 1).

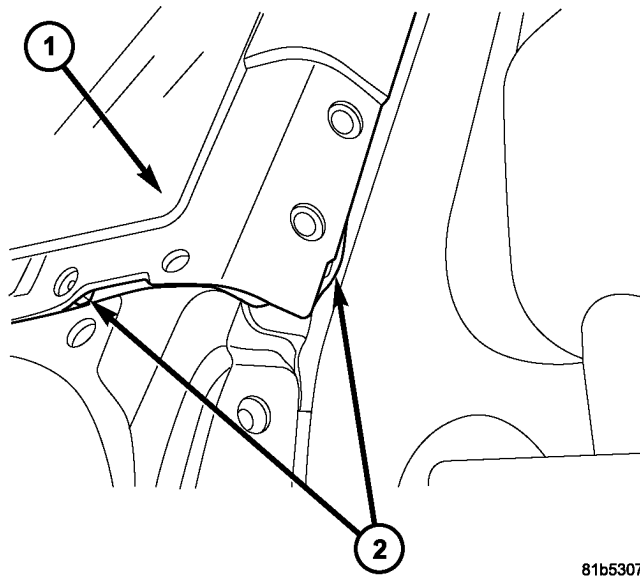
**Fig. 2 CAULK APPLICATION**

- 1 - LOWER LEFT CORNER OF WINDSHIELD
- 2 - APPLY CAULK BETWEEN ARROWS

- 
- 2. Apply caulk to windshield frame weld flanges along rear of frame extending up 30 mm (1.25 in.), and forward, around frame for 65 mm (2.5 in.) (Fig. 2).
  - 3. Reinstall windshield frame reinforcement bracket.
  - 4. Tighten the windshield frame reinforcement bracket fasteners to 15-25 Nm (11-18 ft. lbs.).
  - 5. Repeat steps 1-4 for the other side A-pillar if necessary.
