**NUMBER:** 23-025-08

Freedom Top - Header Seal - Water Leak In Area Of Dash

2007 - 2008 (JK) Wrangler

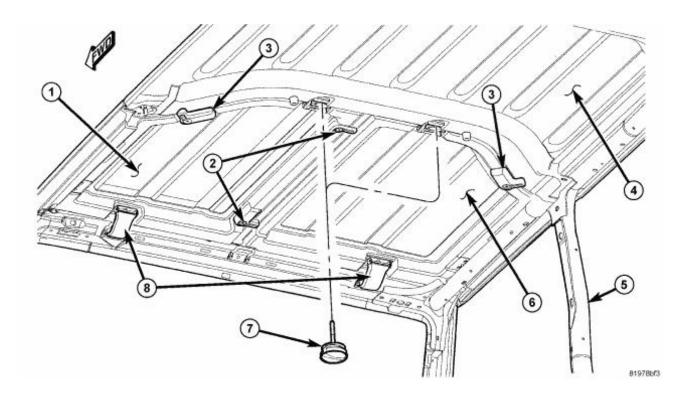
Fig. 1 HARD TOP INSIDE FULL VIEW

- 3. Inspect the Freedom Top panels to ensure that they are installed correctly (Fig. 1). If not, then note this condition so that the correct procedure for installing the Freedom Top panels to the hard top can be reviewed with the customer. To ensure that the panels are installed correctly perform the following steps in order. When installing each Freedom Top panel, always close the windshield latch first.

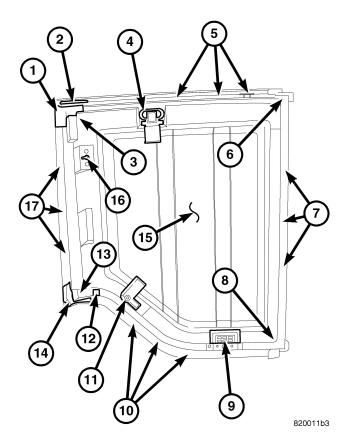
Fig. 2 RIGHT FREEDOM PANEL COMPONENTS

3. Verify Freedom Top has been updated with all of the proper foam and butyl parts as shown in SB # 23-020-08 Dated June 20, 2008. (Fig. 2) shows placement of these components.

If SB # 23-020-08 has not been completed and leaks are occurring at the windshield header, the Freedom Tops will require resealing in conjunction with the header seal replacement. Perform SB # 23-020-08 before proceeding with this bulletin.
