NUMBER: 23-030-07 REV. A

Whistle-Like Sound Due To Gap Between Leading Edge Of Header Seal And Windshield Frame

2007 - ****2008**** (JK) Wrangler

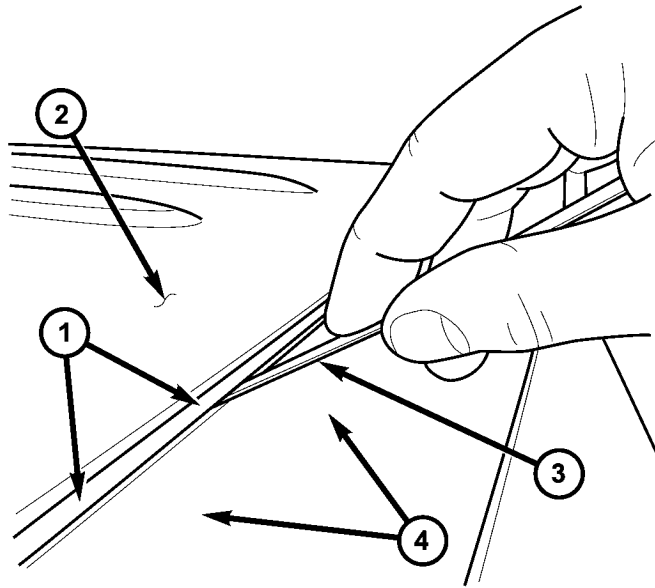
Fig. 1 MEASURE GAP - SEAL TO BODY

The customer may experience a whistle-like sound along the top of the windshield. This sound may be caused by the position of the windshield header seal to the windshield frame. This condition may occur if a gap, that is greater than 1 mm (0.040 inch), is present between the leading edge of the windshield header seal and the top of the windshield frame.

1. Using a blade type feeler gauge, measure along the leading edge of the windshield header seal to the windshield frame. The allowed gap between the leading edge of the header seal to the windshield frame is 1 mm (0.040 inches) or less ([Fig. 1](#)).

2. Is there a gap between the leading edge of the header seal and the windshield frame that is great than 1 mm (0.040 inches)?
 - a. If YES >>> then perform the Repair Procedure.
 - b. If NO >>> then STOP. This bulletin does not apply. Further diagnosis is required.

1. If hard top equipped, remove the left and right front sections of the Freedom Top.
2. If soft top equipped, release the soft top from the windshield header and partially fold back, out of the way.
3. Carefully remove the rivet at each end (side) of the old windshield header seal.
4. Remove the old windshield header seal from the windshield frame.

5. Thoroughly clean the top of the windshield frame of any old adhesive residue using Mopar Super Kleen Bug, Tar, and Spot Remover (or equivalent naphtha solvent) or an isopropyl alcohol wipe. Follow container instructions.

8. Loosely position the header seal to the windshield frame.
9. Closely inspect that the header seal end details fit correctly at the top corners of the windshield frame. Insure that the rivet holes in the seal line up with the holes in the windshield frame. Verify that the lip of the header seal fits properly onto the A-Pillar windshield frame flange.

10. Slowly push the header seal channel (the extrusion portion of the seal) onto the windshield frame.
11. Install a new rivet at each end of the windshield header seal.

12. Completely remove the red header seal adhesive release liner from the back of the seal.
13. Carefully secure the header seal to the windshield frame. Verify that the header seal is not overflush to the windshield frame.
14. Apply firm pressure to the header seal and adhesive, to bond the header seal to the windshield frame.
15. Verify that the new windshield header seal is correctly installed.
16. Install the hard top or soft top to the windshield header.
