NUMBER: 23-037-07

Rear Lower Corner Of Soft Top May Not Stay Tucked To Rail Retainer On Body

2007 (JK) Wrangler

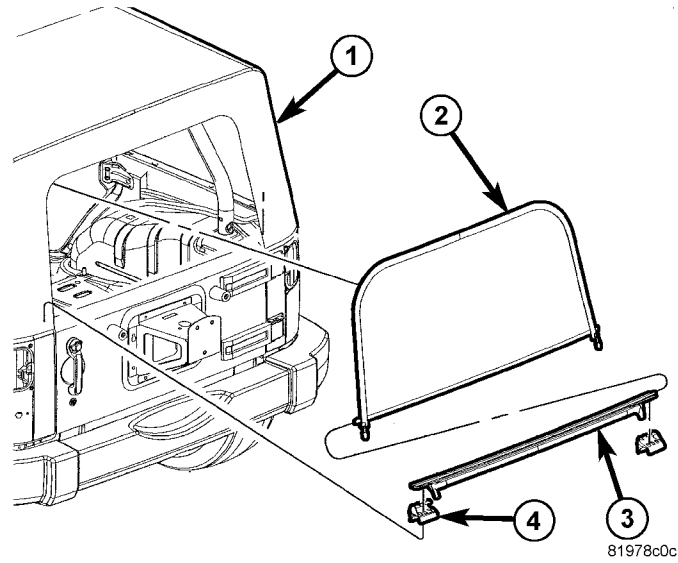
Fig. 1 REAR TAILGATE RETAINER BRACKET

The customer may notice that the left or right rear lower corner of the soft top may not stay tucked to the body. Closer inspection may reveal that the plastic bracket, used to secure the rear tailgate retainer (bar) in place, may not stay attached to the rail retainer on the body.

1. Open the rear tailgate.
2. Separate the bottom edge of the rear soft top from the rear tailgate retainer brackets (both sides) .
3. Unzip each side of the rear window zipper by about 254 mm (10 inches).
4. Separate the bottom edge of the rear window from the rear tailgate retainer.
5. Remove the rear tailgate retainer (bar) from the vehicle.
6. Remove both (left and right side) rear tailgate retainer brackets.
7. Install new left and right rear tailgate retainer brackets.
8. Install the rear tailgate retainer (bar) to the vehicle.
9. Install the bottom edge of the rear window to the rear tailgate retainer.
10. Zip up (close) both sides of the rear window zipper.
11. Install the bottom edge of the rear soft top to the rear tailgate retainer brackets and body.
12. Close the tailgate.
