**NUMBER:** 23-014-07

Difficulty Releasing Soft Top Plastic Edge Retainers From B-Pillar Area Of Door Frame

2007                      (JK)                      Wrangler

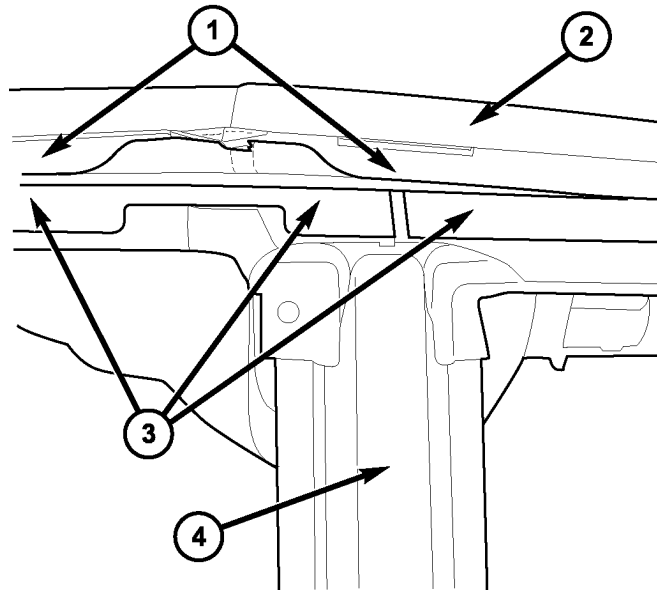
**Fig. 1 SOFT TOP RETAINERS - RIGHT SIDE**

The customer may experience difficulty when attempting to lower/remove the 4 door soft top. The customer may not be able to easily release/remove the soft top plastic edge retainers at the rail on top of the door frame in the immediate area of the B-Pillar.

- 1 - Soft Top Edge Retainers (Plastic) - Location Where Material Will Be Removed From Each Retainer
  - 2 - Four Door Soft Top (Right Side View)
  - 3 - Right Side Door Frame - Retainers Engage Door Frame Channels To Retain Edge Material Of Soft Top To Vehicle
  - 4 - "B" - Pillar (Four Door)
-

2. Locate the plastic edge retainers at the B-Pillar (Fig. 1).

3. Remove the right side soft top edge retainers from the door frame.
4. Protect the soft top fabric from damage by isolating the plastic retainers from the soft top fabric. A clean fender cover can be used.
5. Using aviation style tin snips, remove plastic material from the front soft top edge retainer (Fig. 2).

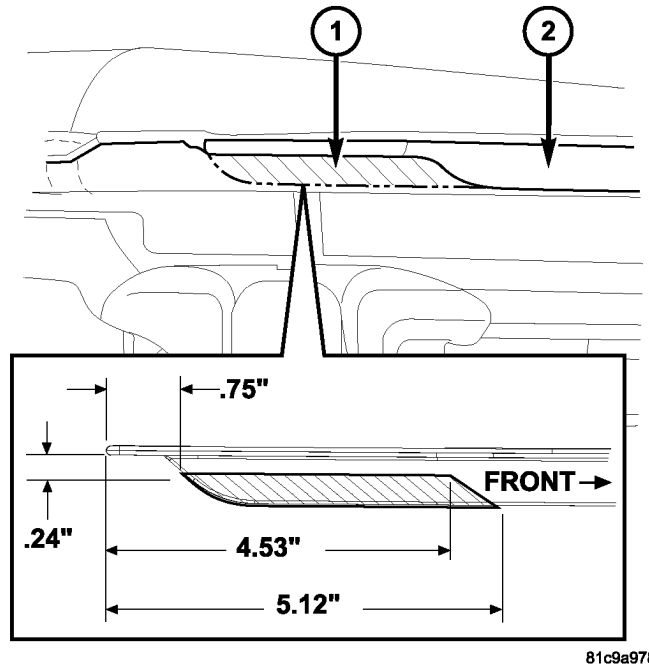
**Fig. 2 REPAIR TO FRONT RETAINER**

- 1 - FRONT Soft Top Edge Retainer - Remove Plastic Material From This Area (Right Side View)
  - 2 - FRONT Soft Top Edge Retainer - Right Side View
-

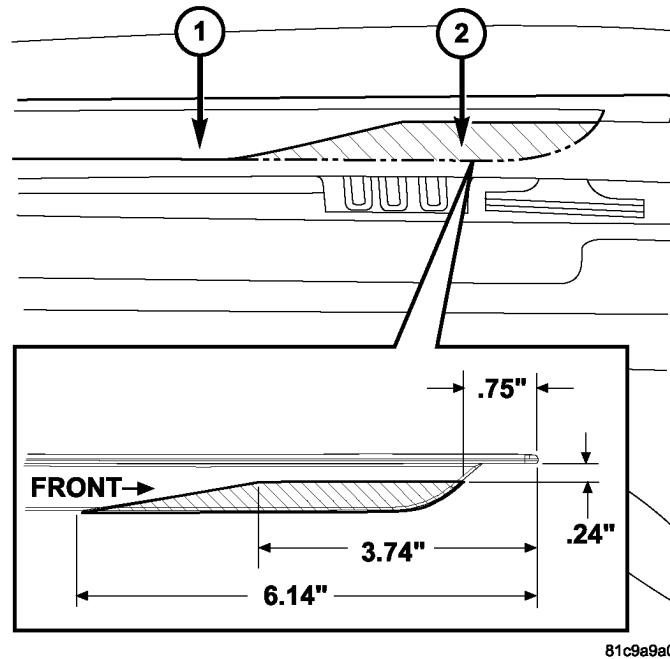
**Fig. 3 REPAIR TO REAR RETAINER**

- 1 - REAR Soft Top Edge Retainer - Right Side View  
 2 - REAR Soft Top Edge Retainer - Remove Plastic Material From This Area (Right Side View)

6. Remove plastic material from the rear soft top edge retainer (Fig. 3).

- 
7. With a file, trim (dress off) the plastic retainers where the material was removed.  
 8. Install the plastic retainers to the door frame.  
 9. Verify that the retainers can be released easily at the B-Pillar.  
 10. Repeat steps 3 through 9 to the left side of the soft top plastic edge retainer.  
 11. Latch the soft top to the windshield header.
