**NUMBER:** 23-025-07

Rear Seat Back May Not Fold Due To Latch Release Cable Loose At Handle

2007 (JK) Wrangler

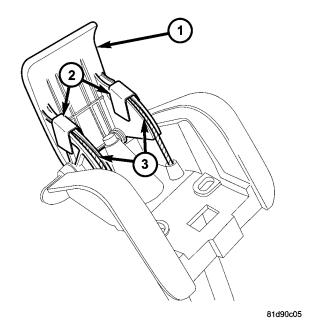
Fig. 1 SEAT BACK RELEASE HANDLE / CABLE

The customer may not be able to unlatch the seat back on the rear seat. This condition may be due to the rear seat back latch release cable. The lug on the end of the release cable may come free of the release handle.

- 1 Rear Seat Back Release Handle (60% Seat Handle Shown)
- 2 Tape Cover Release Cable End Lugs
- 3 Rear Seat Back Latch Release Cables

- 1. Perform this repair to both rear seat back release handles, for the 60% and the 40% seat backs.
- 2. If rear seat has a 60/40 split seat back (two handles), then cut three (3) 13 mm x 40 mm (0.5 in. x 1.5 in.) tape strips from the larger piece of nylon flock tape. If rear back has a single seat back (one handle), then cut two (2) 13 mm x 40 mm (0.5 in. x 1.5 in.) tape strips from the larger piece of nylon flock tape.
- 3. For each rear seat back release handle (two handles on the 60/40 rear seat), install tape over each release cable end lug (Fig. 1).
- 4. Verify that the tape is fully seated on both release handles.
